RICS **Building Survey**...

Date of inspection

17 April 2019

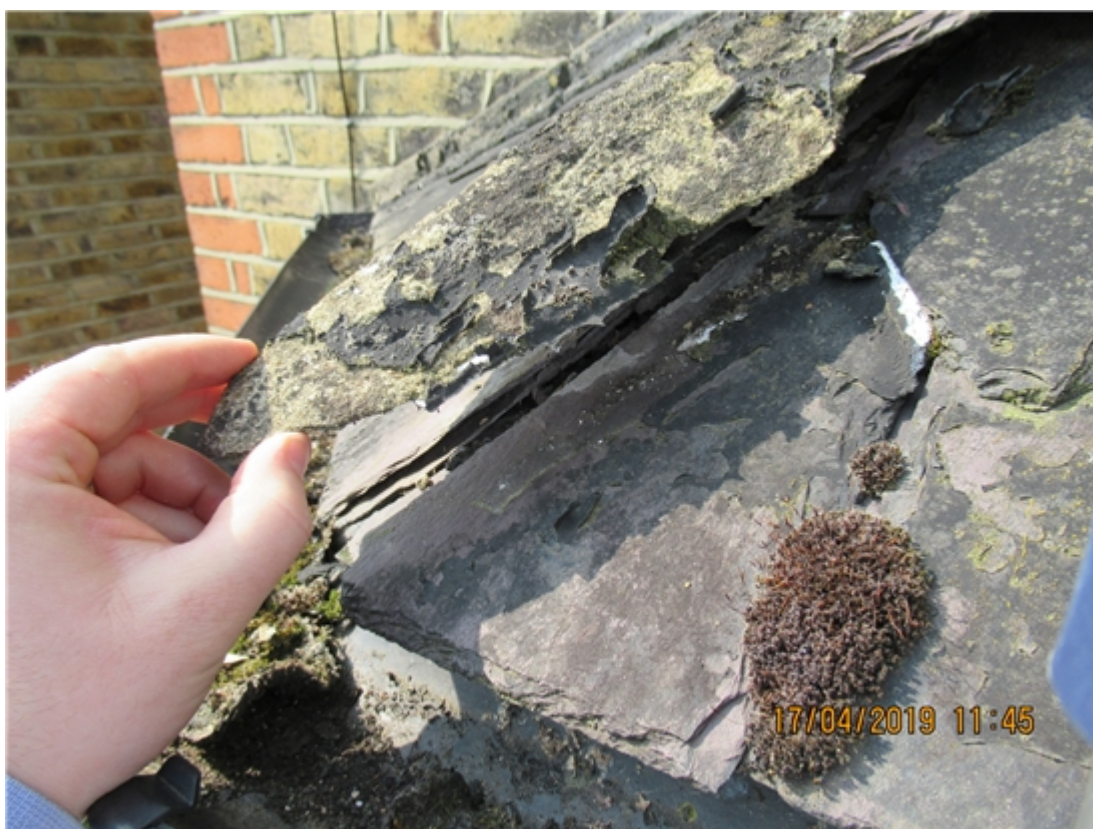
The slates appear to have been painted. There is delamination to slates and failure of mortar fillet at abutment of the front external wall. The mortar detail between in place of hip tiles could be lifted by hand. Towards the top, there is an exposed timber which appears de-natured. Some slates near the line of gutter have slipped slightly although can be pushed back in position. Lower slates at eaves level were found to be chipped.

Lifting of mortar to front bay roof. Delamination to slate covering.

I recommend strip and replacement of this roof covering complete. The purchaser also should budget for repairs or replacement to roof structure. The works should be subject to detailed design and specification activity. In renewing the roof, it is likely to be a requirement to install insulation in order to comply with the Building Regulations (Approved Document Part L). Dependent on the design of the roof, consideration should be given to roof structure ventilation. Detailing at building abutment ideally would be sheet lead designed and installed in accordance with best practice.

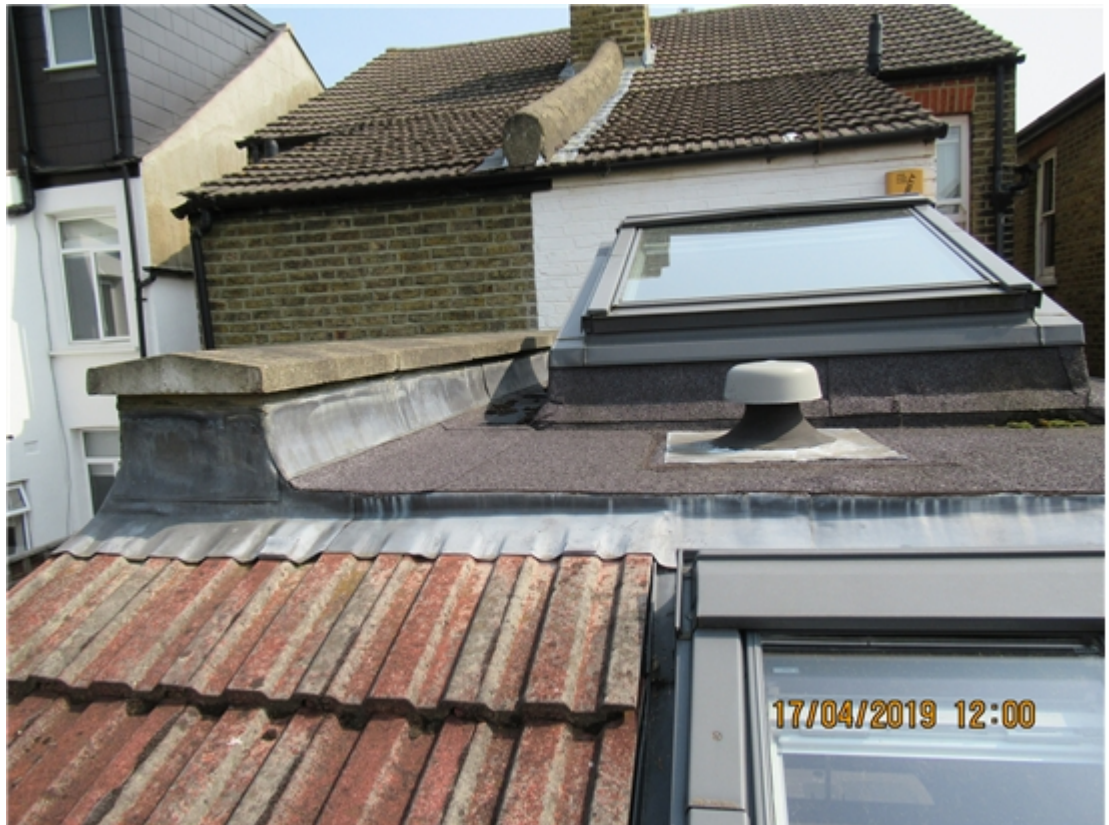
General view of rear extension roof and north parapet.

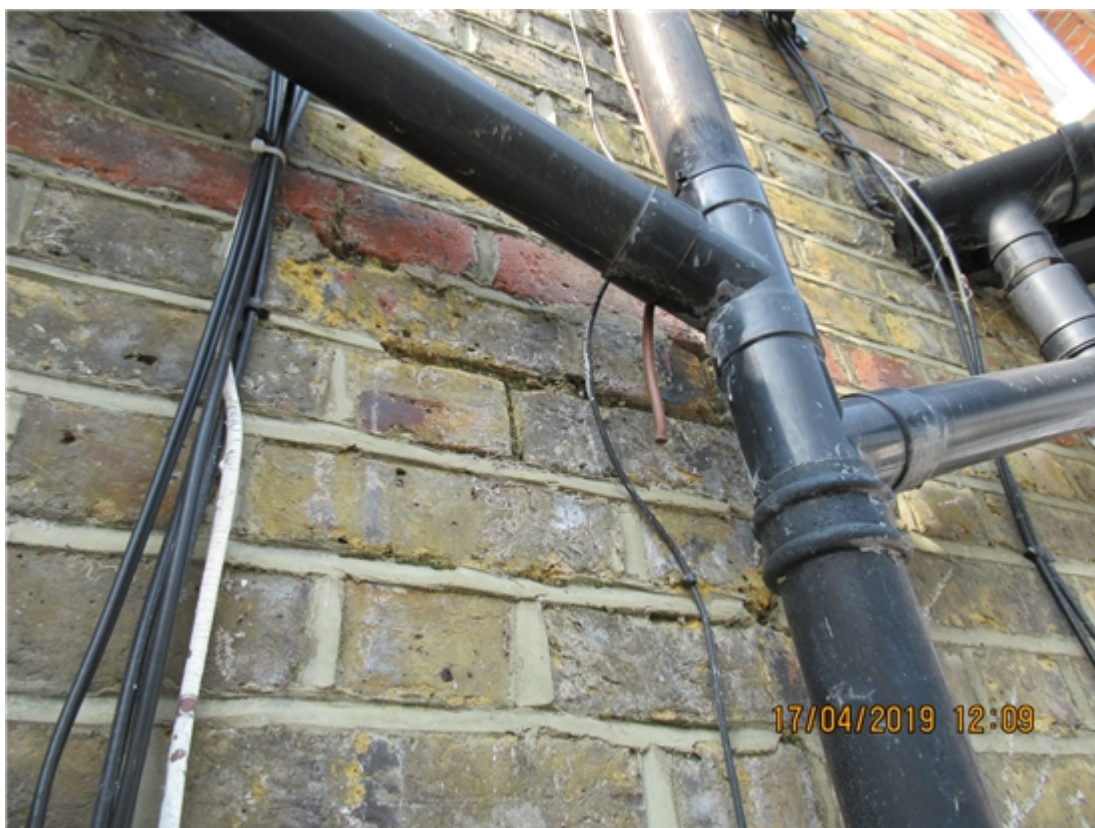
Behind the downpipe and in proximity, mortar has failed from brick joints and moss was noted growing. There was evidence of organic growth to the wall in the form of dead plant matter. My suspicion is previous plant growth has been removed.

Rainwater goods arrangement north of ground floor bay. Failing mortar to brick joints visible.

My recommendation is to conduct a water test to confirm that rainwater goods are performing their function. It would be sensible if the purchaser allowed to renew the bay downpipe and guttering which can be replaced as part of the roofing work recommended in E2. The downpipe, which is plastic has been painted, plastic rainwater goods should not be painted.

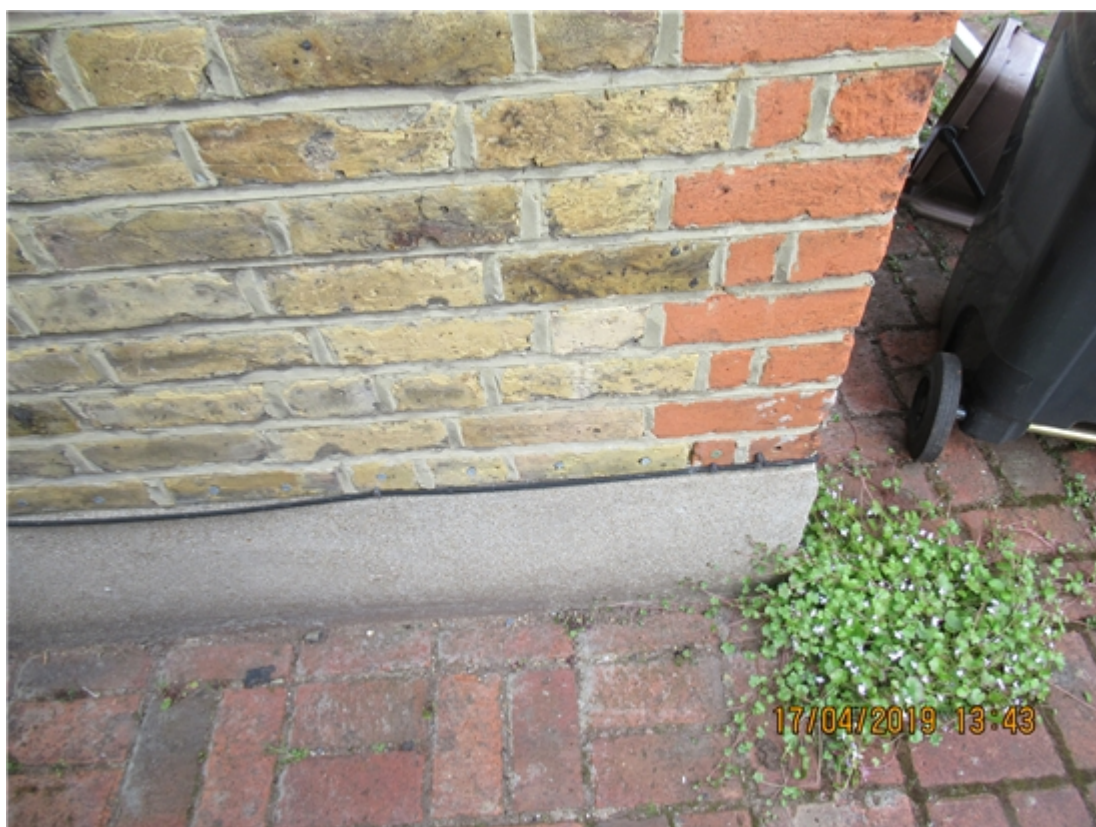
Right of the bay is missing mortar pointing to brick joints where organic growth used to be growing. Mortar in this location should be repaired in suitable mortar mix. I recorded evidence of possible DPC injection travelling up the line of party wall in this location. DPC injection in this location is likely to have been an inappropriate course of action.

Suspected DPC injection holes noted above render plinth.

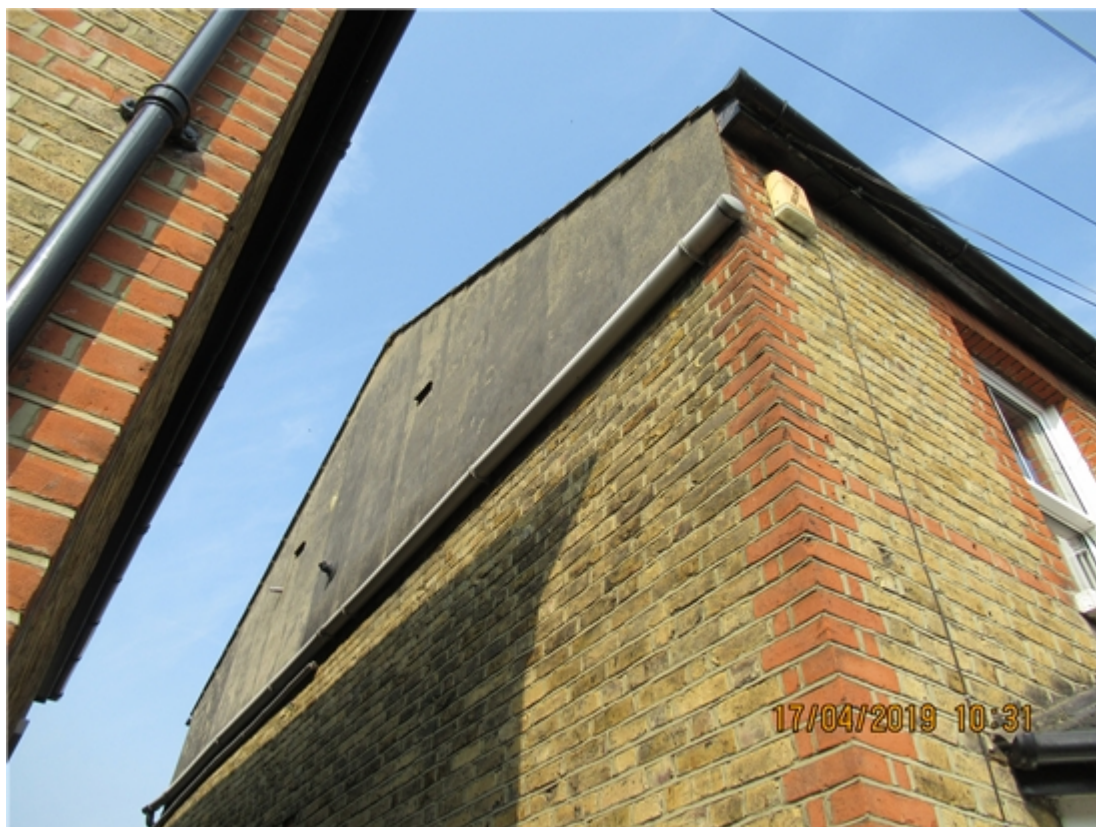
The upper level of unpainted render to flank wall has cracks running through it. I was unable to confirm render bond integrity and this should be checked. Cracked or de-bonded render should be hacked off and renewed.

Upper level of flank wall in unpainted render. I envisage this to be half brick thick masonry construction.

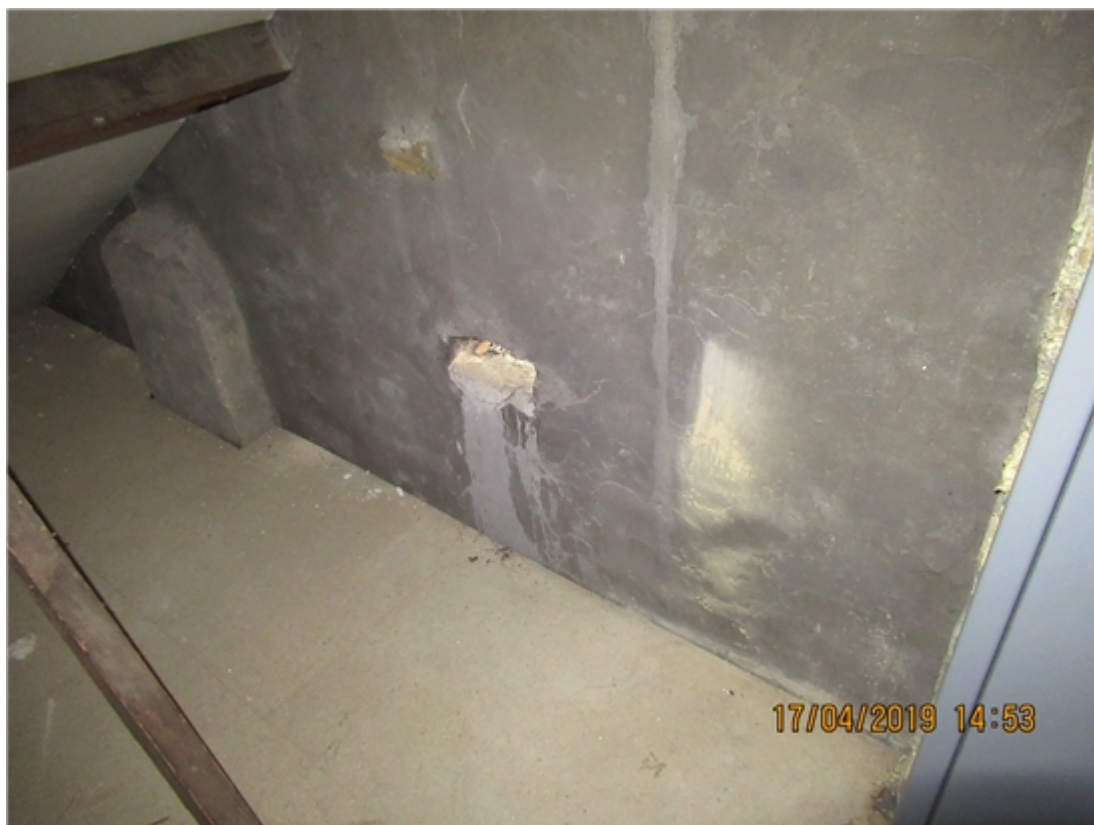
Inside face of south flank wall likely to be half brick thick.
